# Tequesta Country Club

Established 1959  
Restored 2013

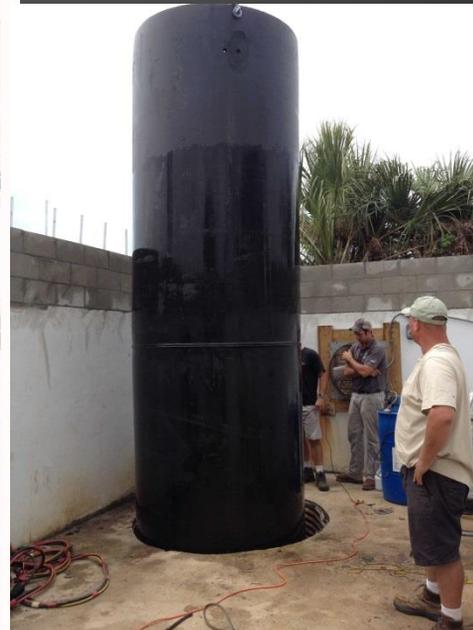
Existing Wet Well

The original irrigation was a single center row metal pipe with a greens loop.

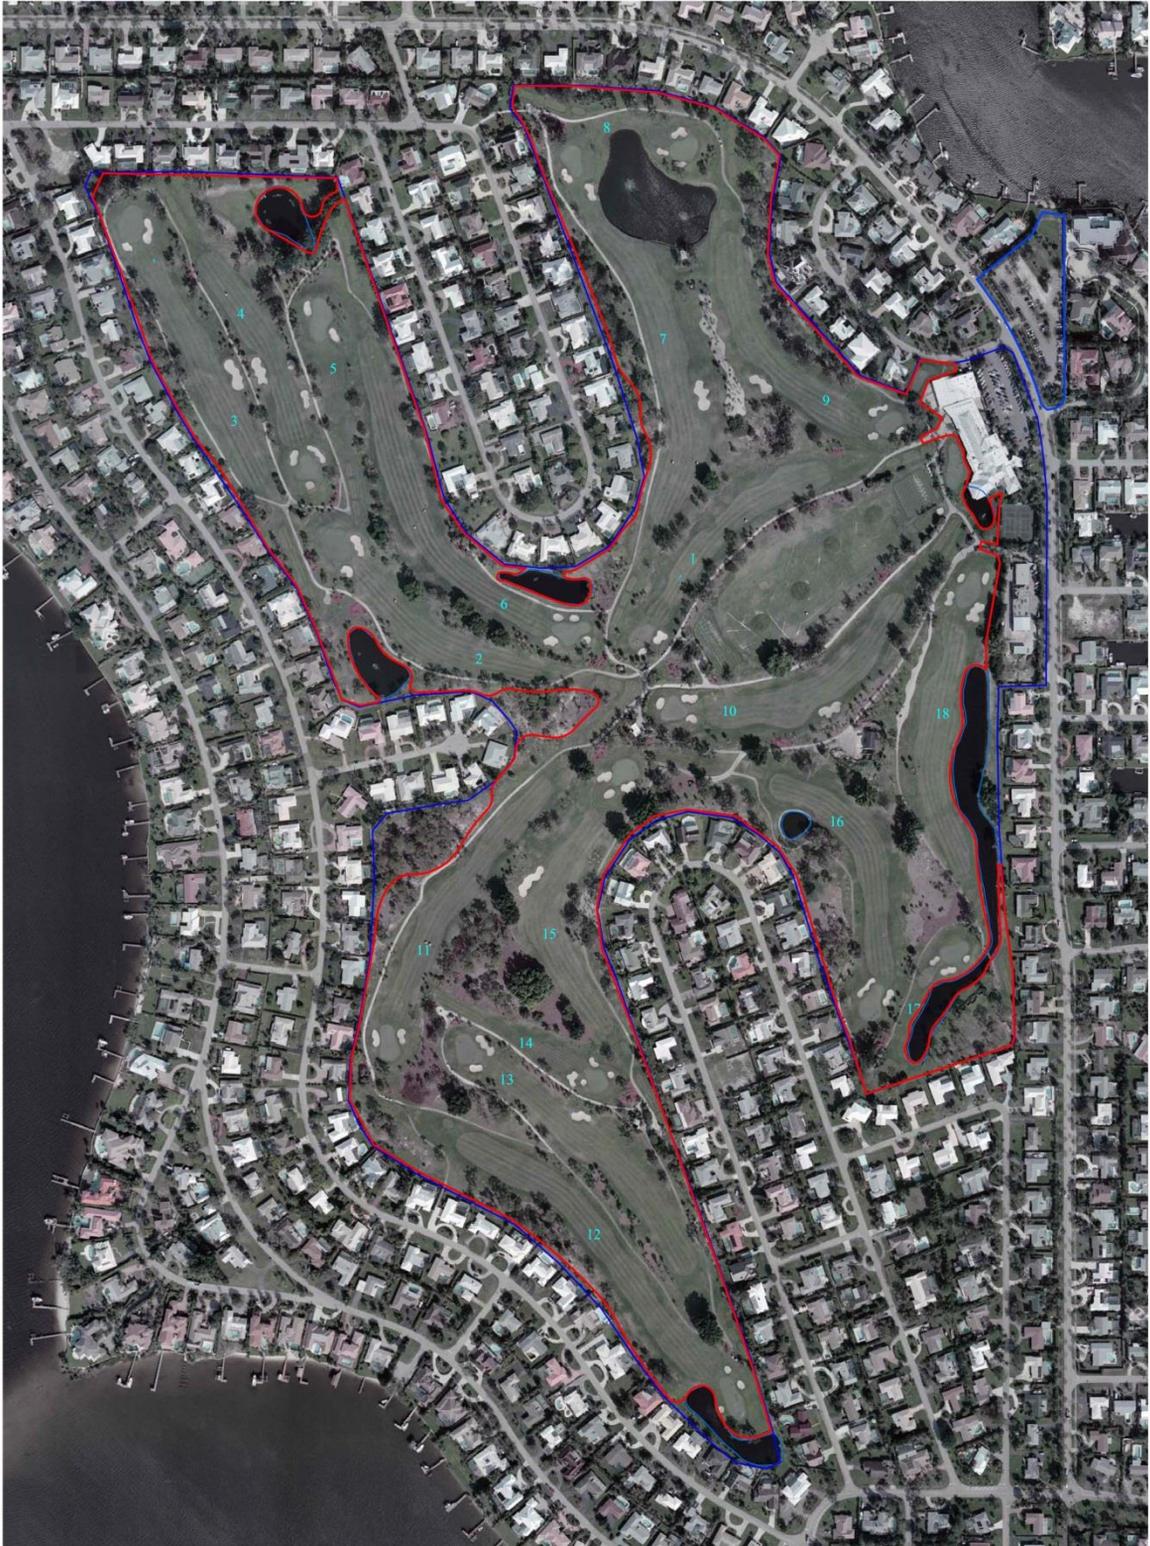
Tequesta Country Club 2008

Pre Construction  
Maintained turf  
108 ac

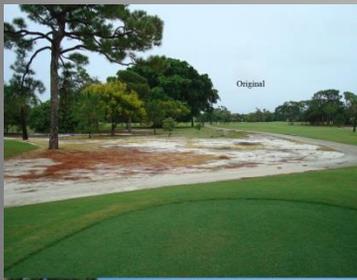
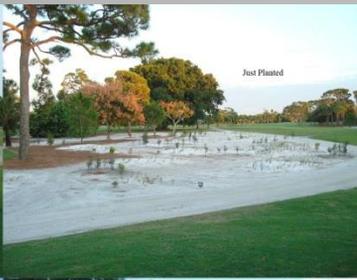
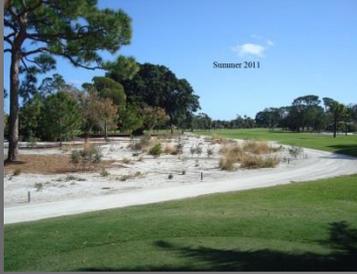
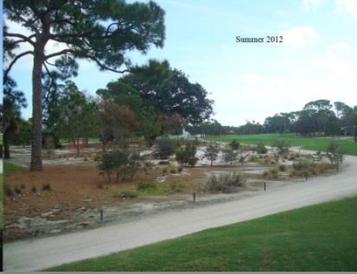
Hole 12 Tee Complex  
Natural Scrub Planting  
Process
